How to conduct your own 'Pre-survey Survey' of a Mono-hull Sail-boat

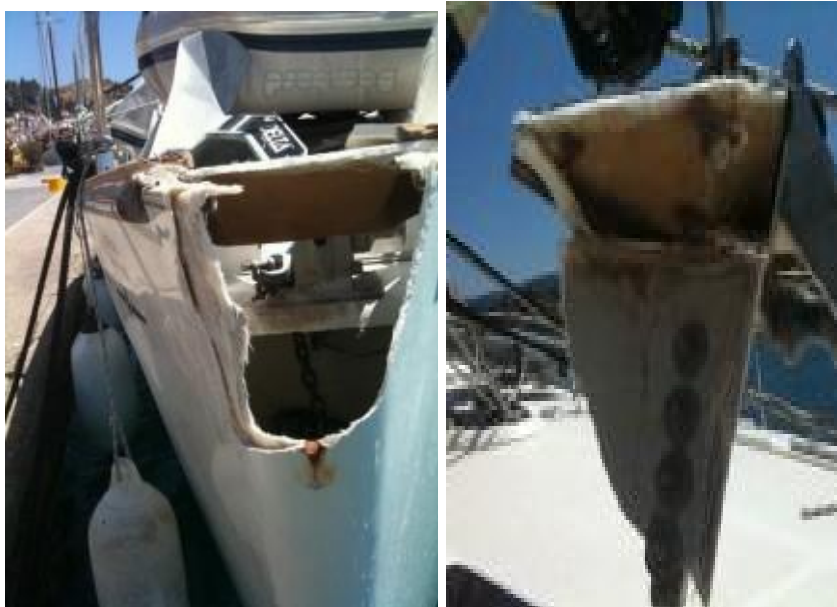
However, while a minority of 'production sail-boats' are notable for build quality, the majority are not. This fact likely passes by the average buyer with nary a blink. The pictures below depict a well known brand European production sail-boat that encountered a mishap while on charter in the Mediterranean. The vessel reportedly did not hit anything to cause the event whereby the bow section separated from the hull. Mere pressure of the rig was evidently sufficient. A close look at the flimsy chopped strand lay-up in this area which is supposed to be a hull strong point, is enough to see why. Where is the roving reinforcement? Look at the deck to hull joint and the absence of reinforcement behind the fittings.

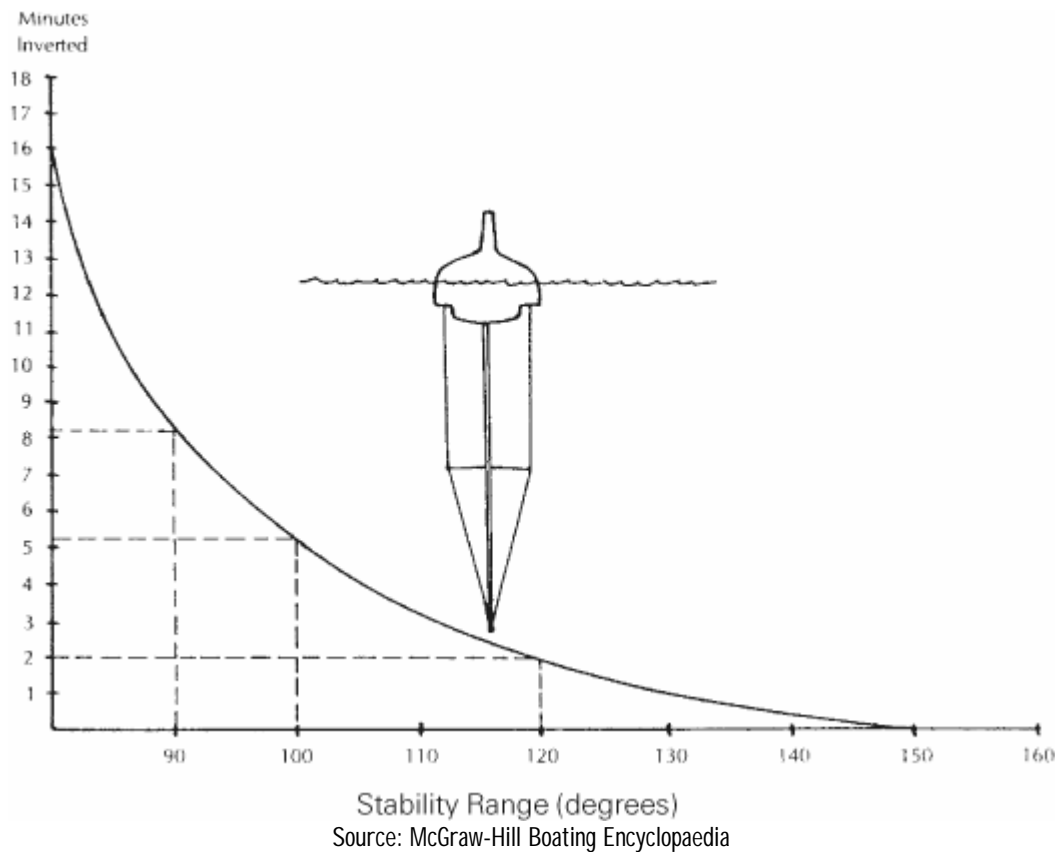
What is the Limit of Positive Stability (LPS) on the Boat You Plan to Take to Sea?

The issue from a sail-boat buyer perspective it is safe to assume: is that you presumably wish to avoid the prospect of being trapped in a sail-boat that inverts 180 degrees and stays put in that position long enough to sink the boat and drown crew trapped inside and/or drown those unfortunates tethered to the deck.

In this respect a yacht with a 120-degree range is almost 3 times less likely to be trapped in the upside-down position than is a boat with only 90 degrees of positive stability; a boat with a 150-degree range, such as the Contessa 32, is ten times less likely to be trapped.

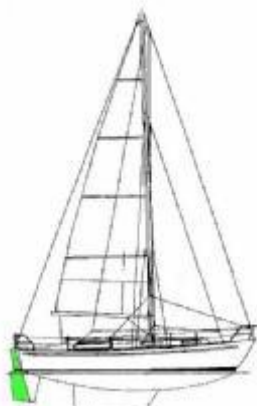
Rudders and steering systems: the simplest most straight-forward steering system on a yacht is a tiller attached to an outboard rudder on pintles.

The tiller is connected to the rudder stock usually via a mortise joint. A tiller provides direct feel and ultimate simplicity. For these reasons your retro-author believes that a tiller is the only way to steer a yacht up to say 35'. This is probably a minority viewpoint. But ridiculous to my eye, is the sight of a 28-30' yacht with a steering pedestal and a large destroyer type wheel.
